# SPECIAL INVESTIGATION REPORT

**BASI REPORT B/902/3307**

**Near Collision on Runway 34  
Sydney (Kingsford Smith) Airport  
11 September 1990**

Report B/902/3307

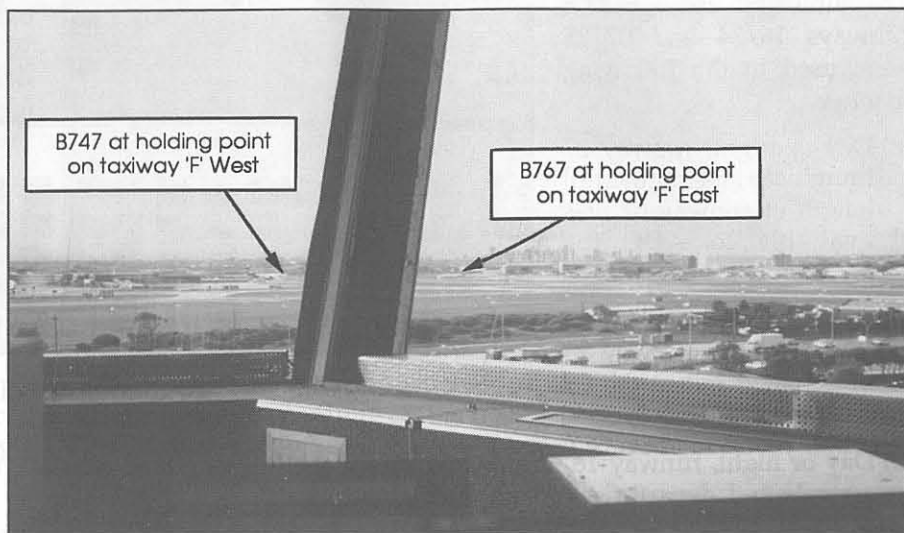
From the ADC 1 normal operating position it is not possible to see the runway between the taxiway 'F' holding points. A structural support beam for the control tower roof obscures approximately 120 metres of the runway adjacent to taxiway 'F'. ADC 1 must move left or right of the console position at least one half metre to gain an unobstructed view of the runway.

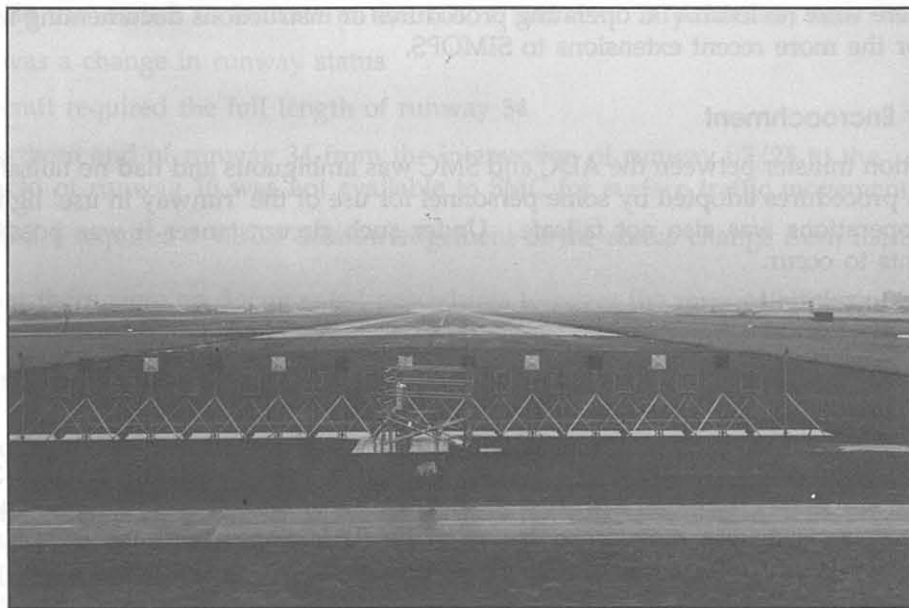
View along runway from 34 threshold.

At the time the photograph was taken a B747 was stationary at the taxiway 'F' West holding point. Light rain was falling; however the aircraft was clearly visible from the 34 threshold at ground level. Unfortunately the B747 is not clearly visible in the photographic reproduction.
